Debris/Ice/TPS Assessment and Integrated Photographic Analysis of Shuttle Mission STS-70

Gregory N. Katnik, Barry C. Bowen, J. Bradley Davis

13 July 1995

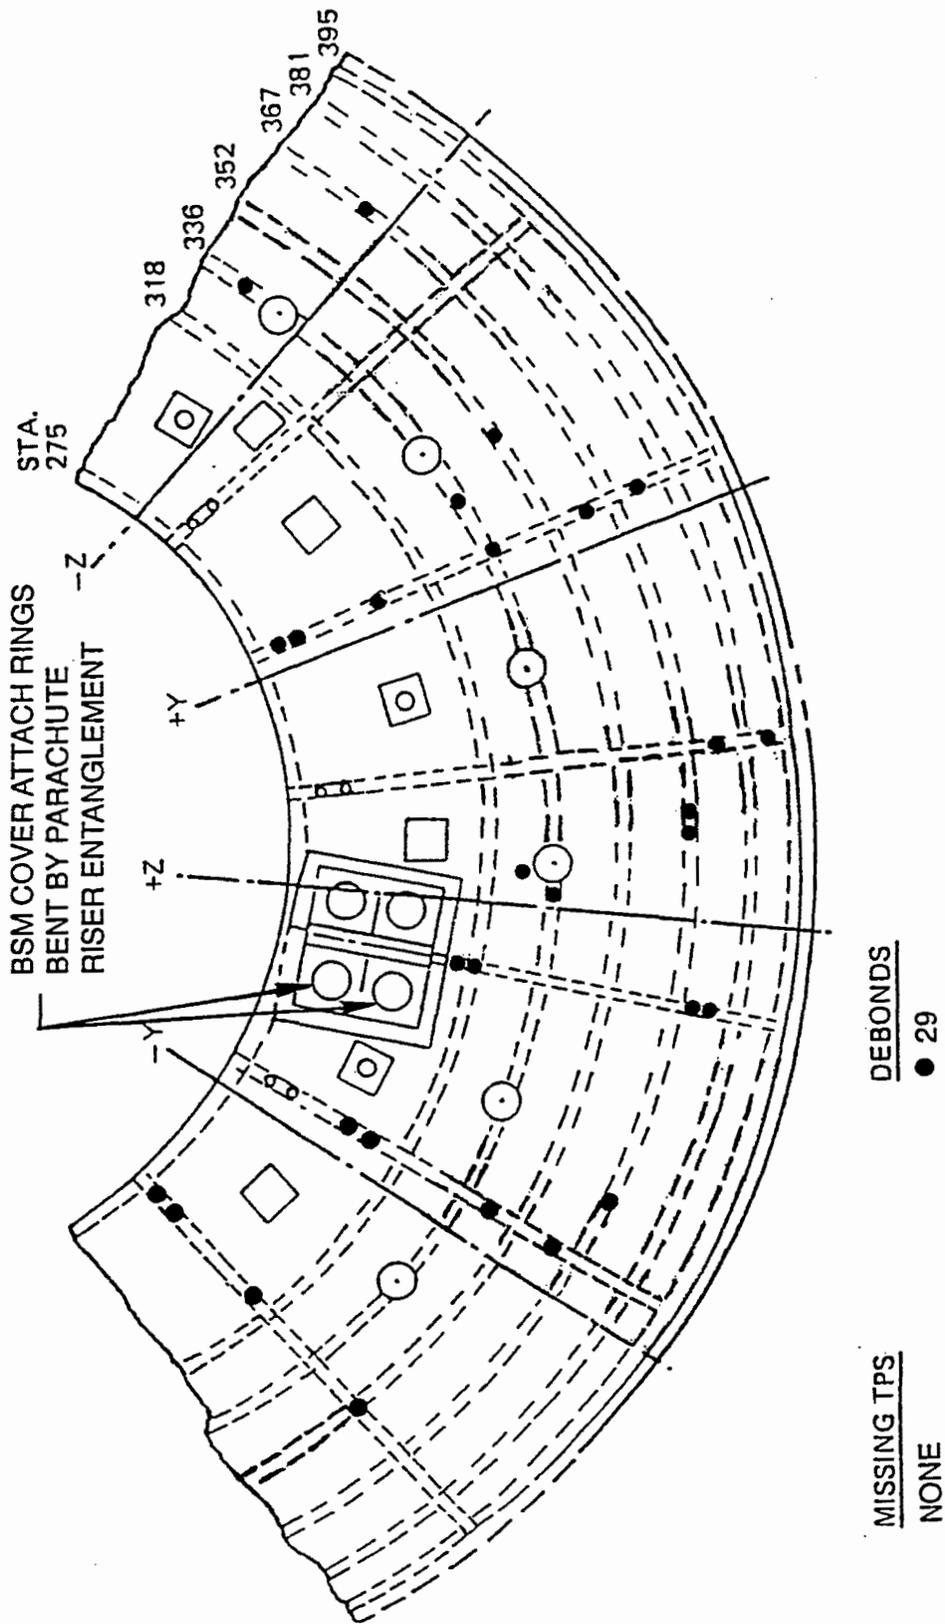
Figure 1 : RH SRB Frustum

The RH frustum was missing no TPS. The number of debonds (29) over fasteners was average (Figure 1). Hypalon paint was blistered/missing where BTA closeouts had been applied. Some of the underlying BTA was sooted. The BSM aero heat shield covers had locked in the fully opened position though the left two cover attach rings had been bent by parachute riser entanglement.

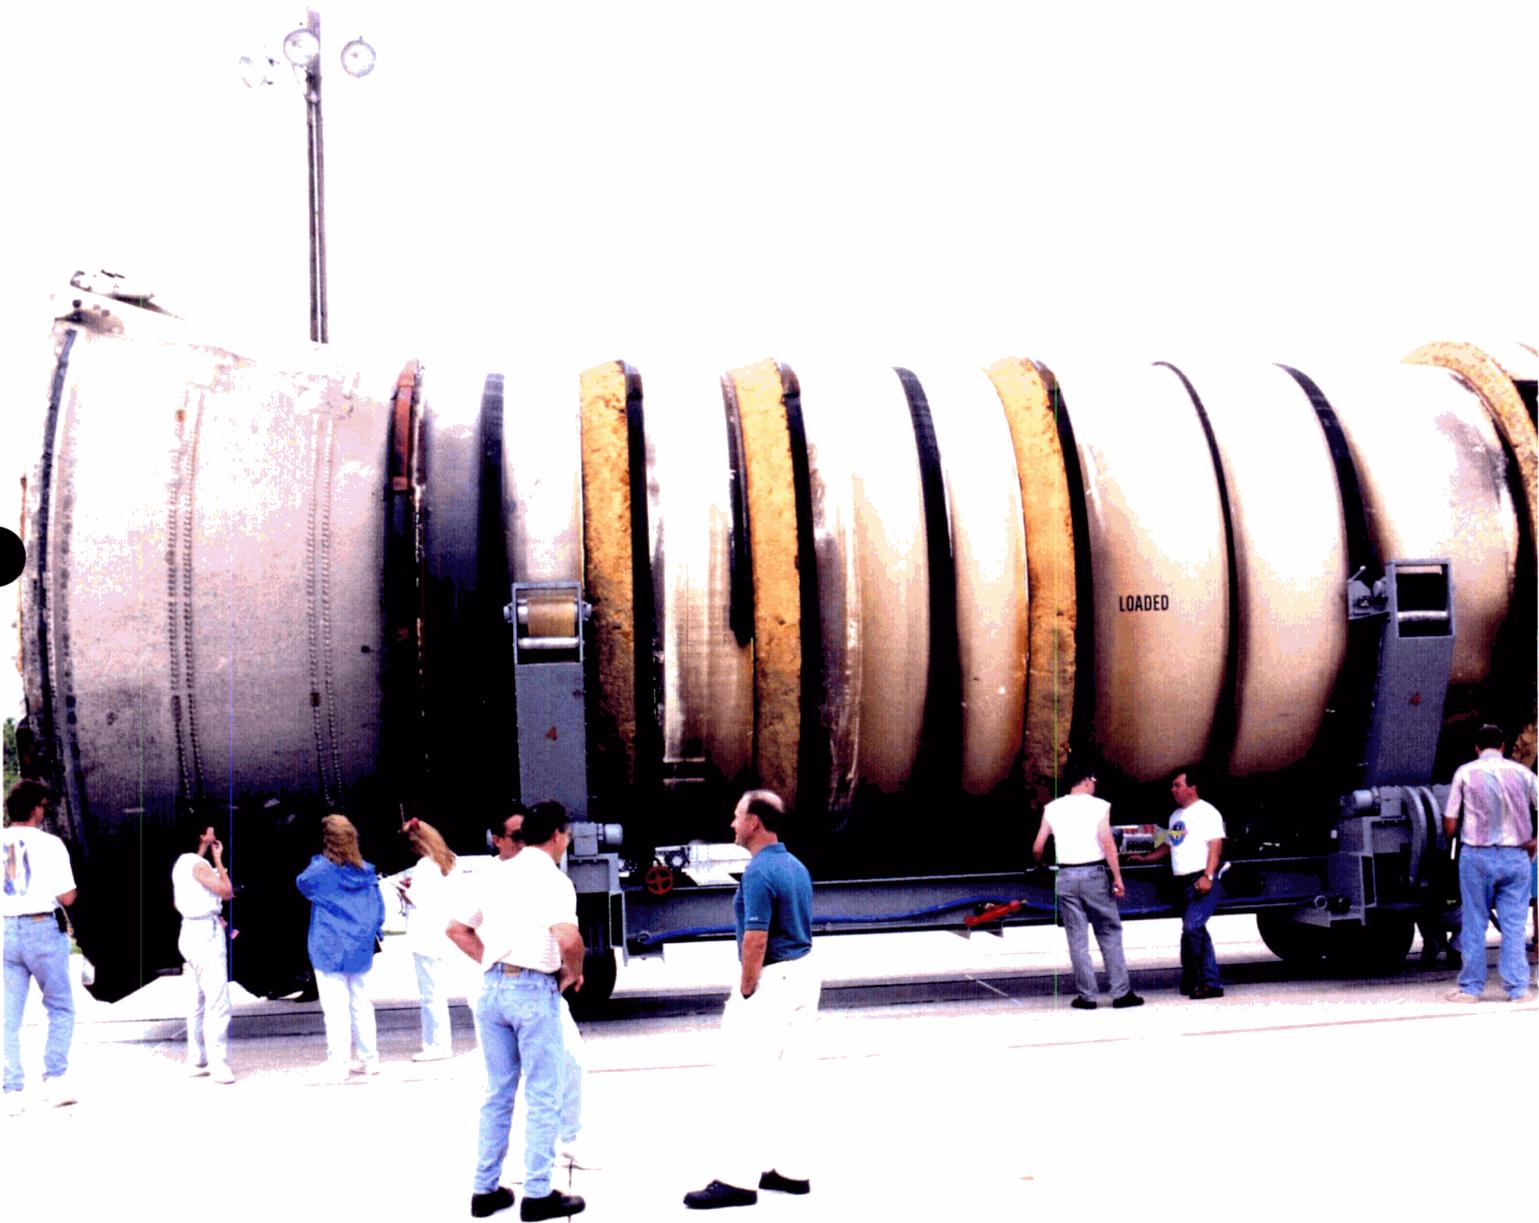
Photo 17 : RH Aft Booster/Aft Skirt

Aft skirt hypalon paint was blistered over areas where BTA closeouts had been applied. A 0.4 inch long by 0.1 inch wide by 0.15 inch deep gouge on the forward-facing surface of the aft outboard BSM fairing (closest to the +Z axis) was analyzed by the MSFC materials laboratory, which determined the gouge was most likely caused by SRM insulation NBR rubber (reference PR PV6290235 and USBI Report BLV-050-95MP). The BSM aft attach bracket adjacent to HDP #1 was missing K5NA to substrate. The HDP Debris Containment System (DCS) plungers were seated and appeared to have functioned properly.

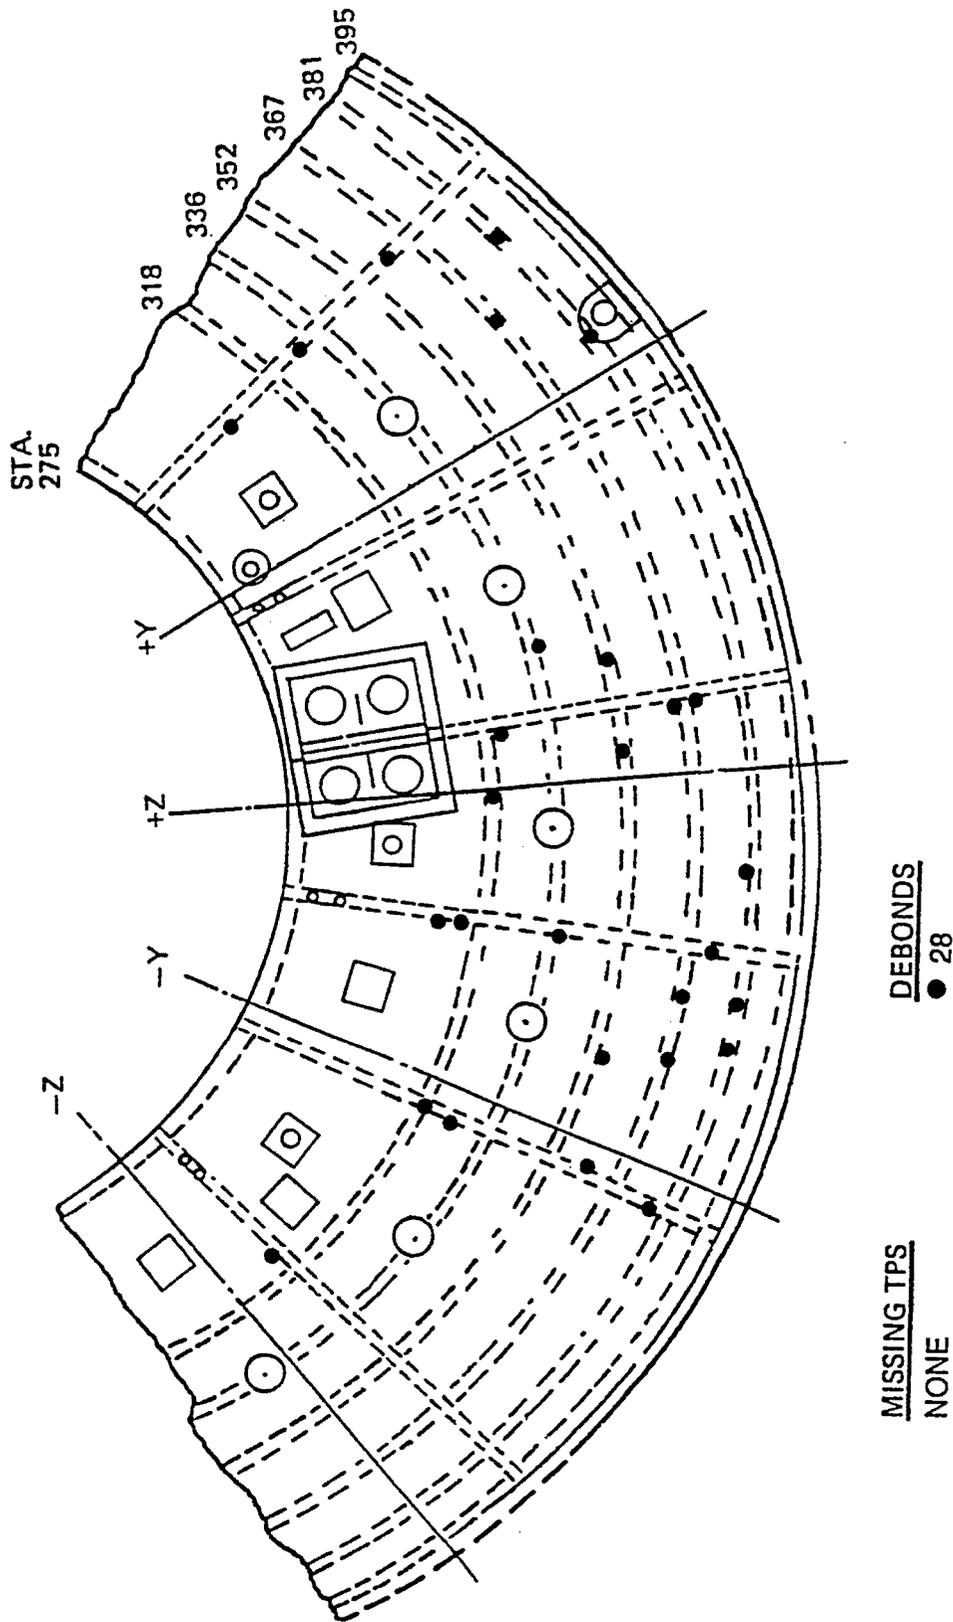
Figure 2 : LH SRB Frustum

The LH frustum was missing no TPS. The number of MSA-2 debonds (28) over fasteners was average (Figure 2). Hypalon paint was blistered/missing along the XB-395 ring frame where BTA closeouts had been applied. Some of the underlying BTA was sooted. The BSM aero heat shield covers had locked in the fully opened position.

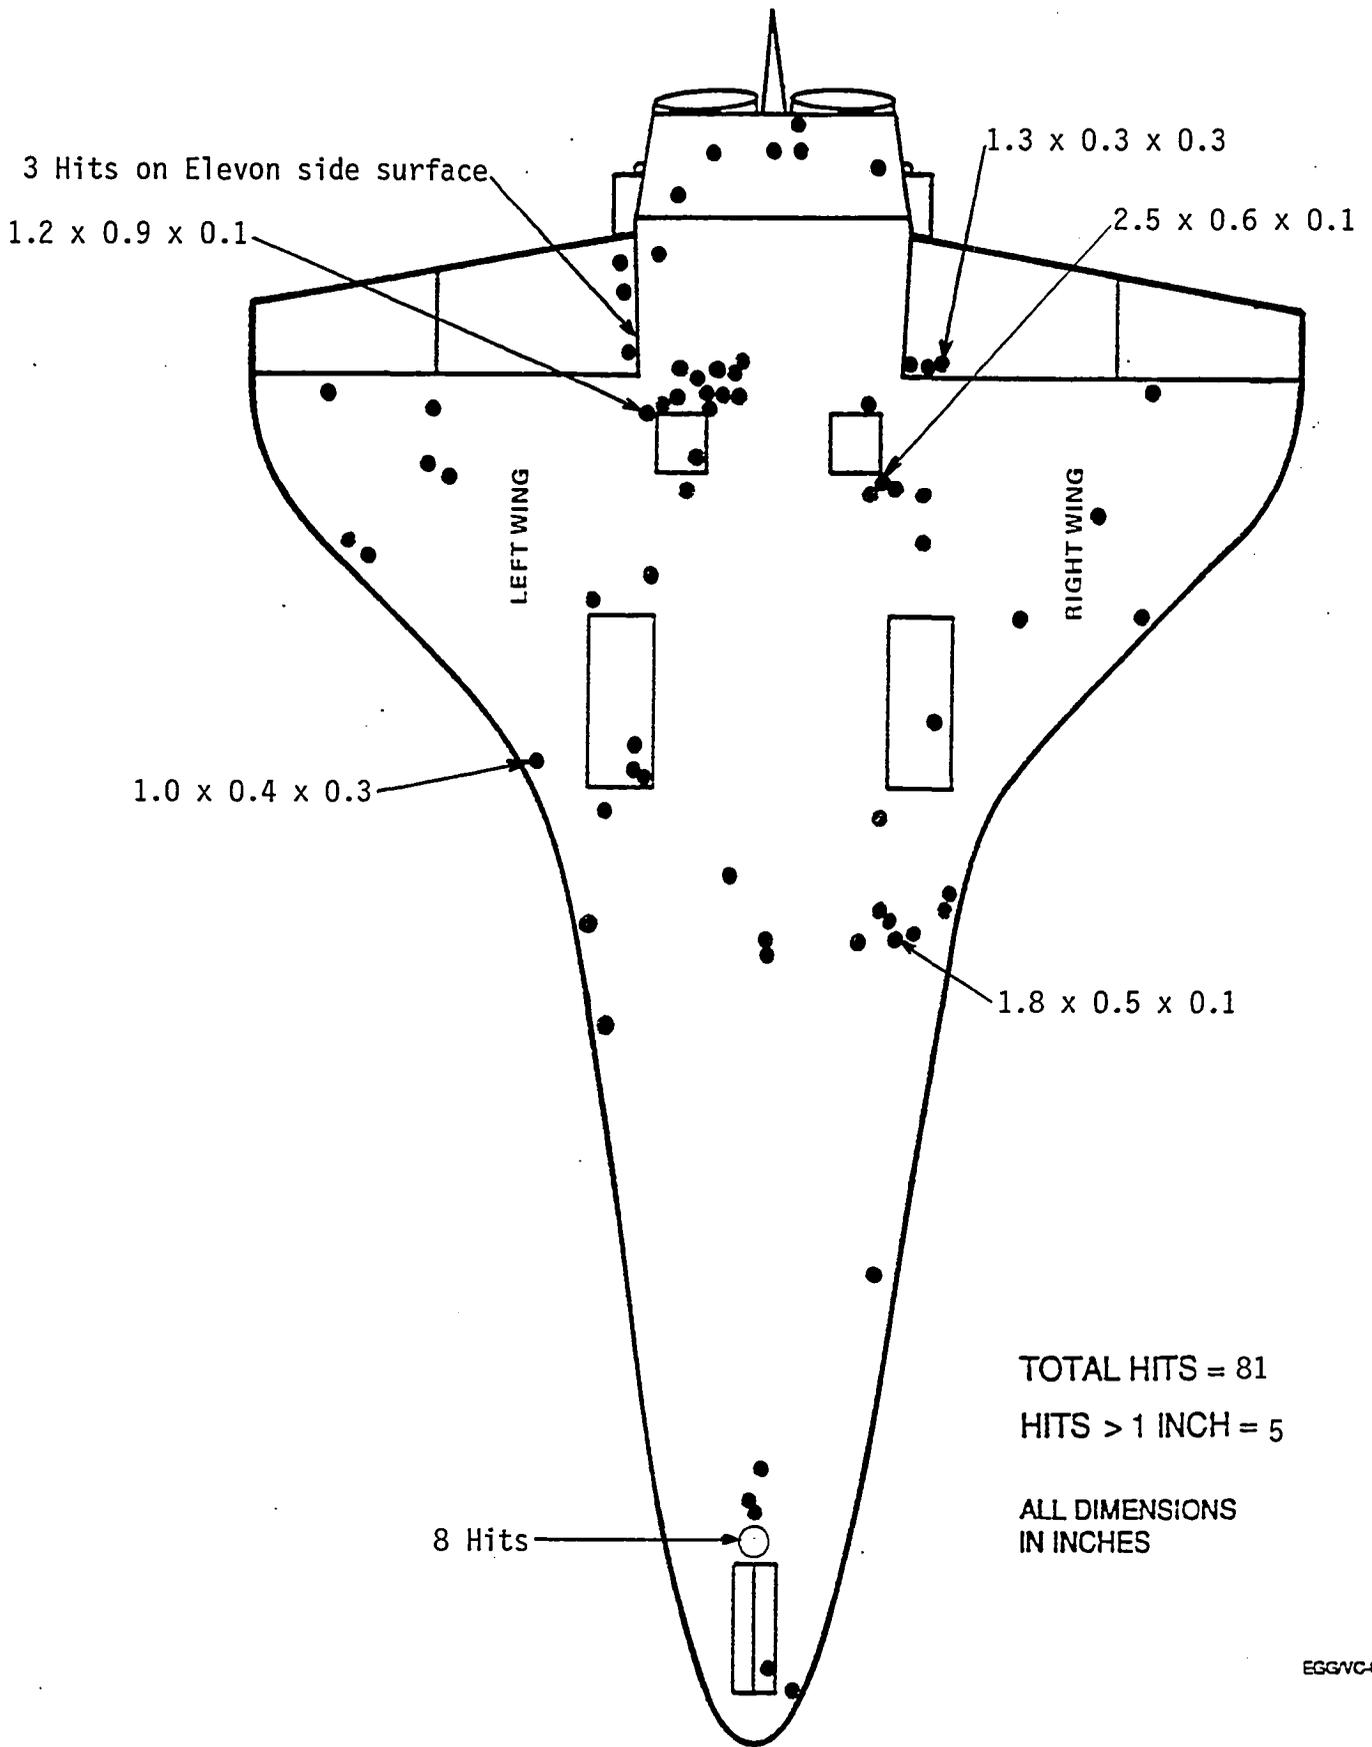
Figure 3 : Orbiter Lower Surface Debris Map

In summary, the total number of Orbiter TPS debris hits was slightly less than average while the total number of hits 1-inch or larger was significantly less than average when compared to previous missions (Figures 7-8).

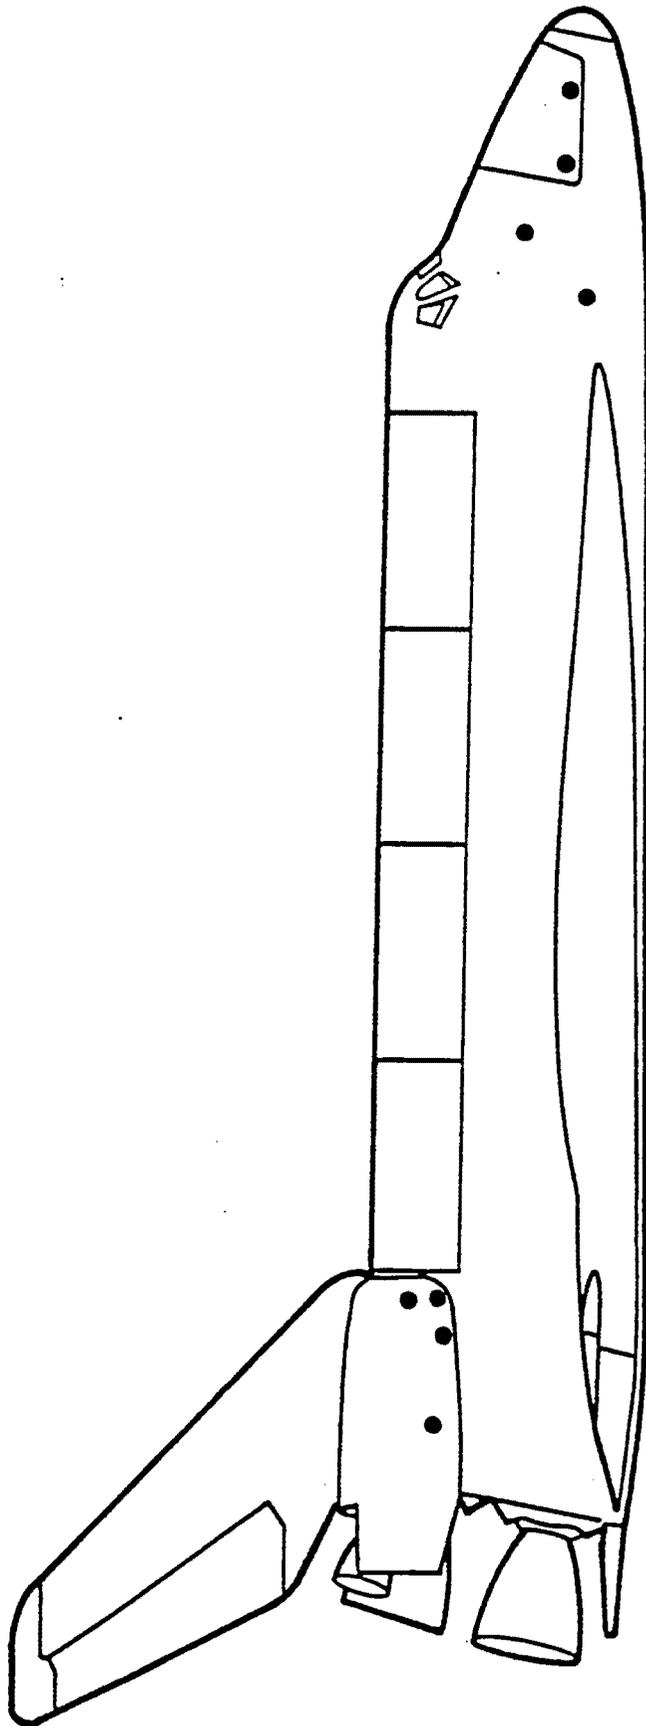
Figure 4 : Orbiter Right Side Debris Map

TOTAL HITS = 8
HITS \geq 1 INCH = 0

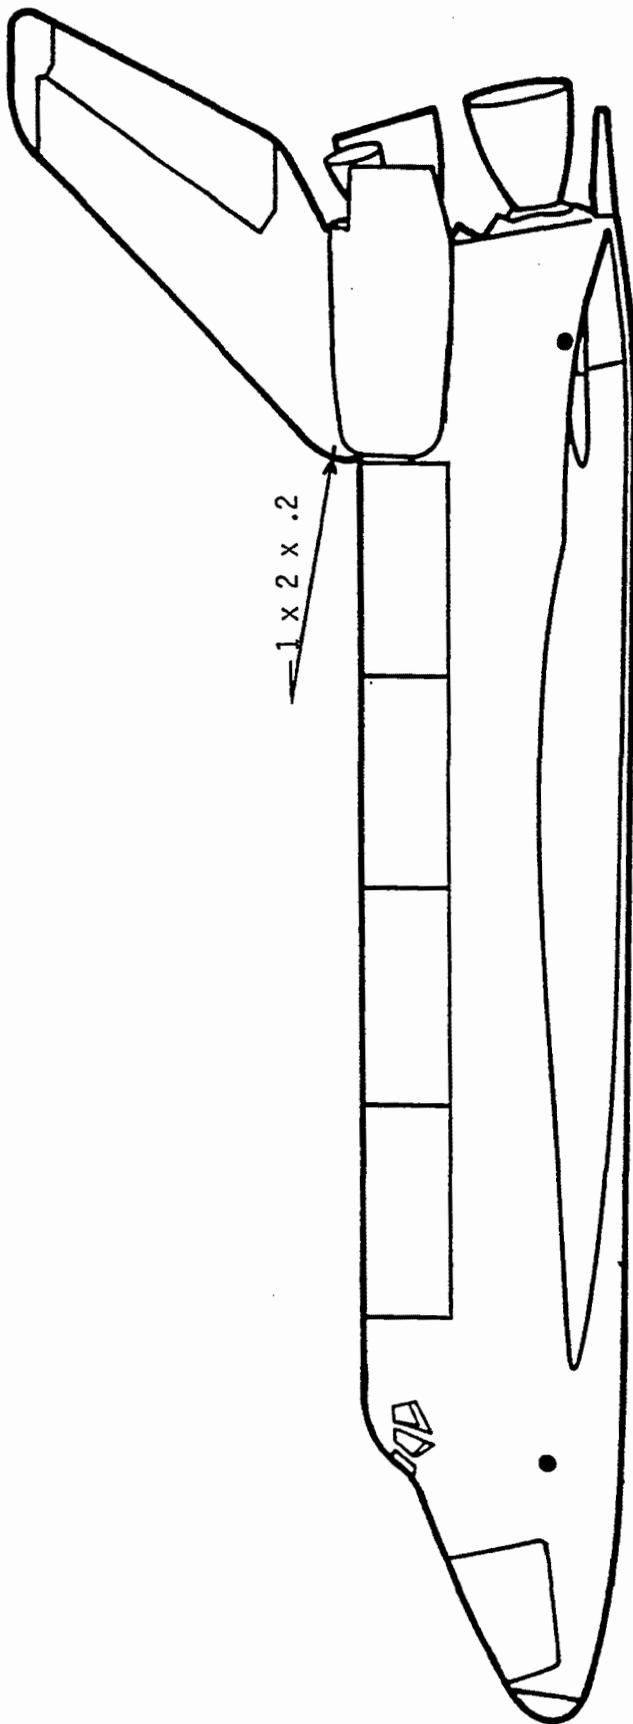
Figure 5 : Orbiter Left Side Debris Map

TOTAL HITS = 3
HITS \geq 1 INCH = 1

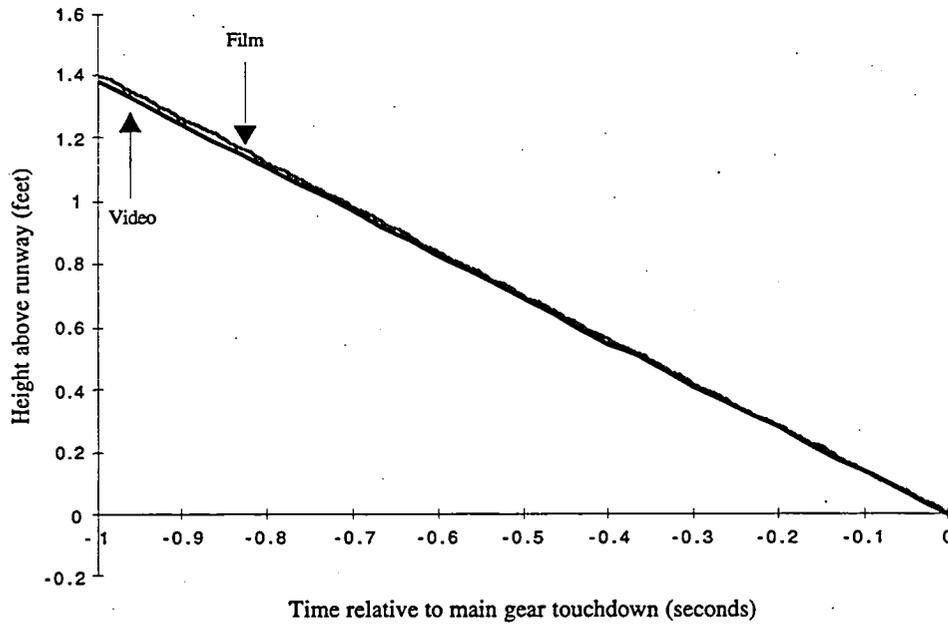
The measured main gear and nose gear sink rate values were found to be below the maximum allowable values of 9.6 ft/sec for a 211,000 lb. vehicle and 6.0 ft/sec for a 240,000 lb. vehicle (the landing weight of the STS-70 Orbiter was reported to be 195,800 lbs.). The sink rate measurements for STS-70 are given in Table 2.5.1. In Figures 2.5.1. and 2.5.2. the trend of the measured data points for both film camera image data and video image data are illustrated.

Figure 2.5.1 (A): Main Gear Sink Rate from Film (EL9) and Video (Runway South) (Shown as Trend of Data Points)

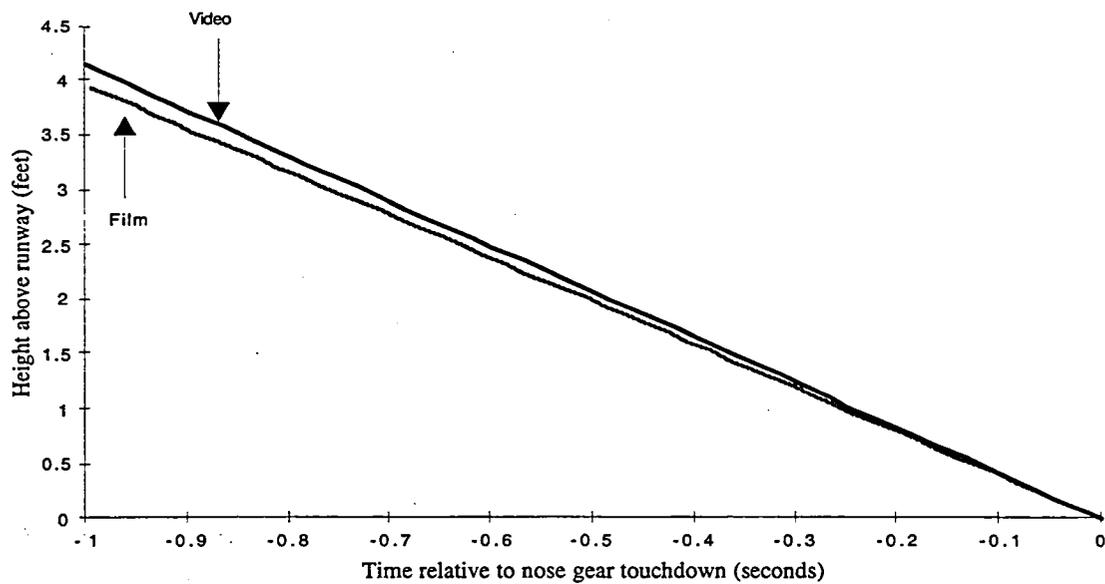
Figure 2.5.1 (B): Nose Gear Sink Rate from Film (EL15) and Video (KTV33L) (Shown as Trend of Data Points)
